**San Lorenzo Community Assoc.
Yorba Linda, CA**

Report #: 1613-0
Beginning: January 1, 2025
Expires: December 31, 2025

**RESERVE STUDY
Update "With-Site-Visit"**

October 11, 2024

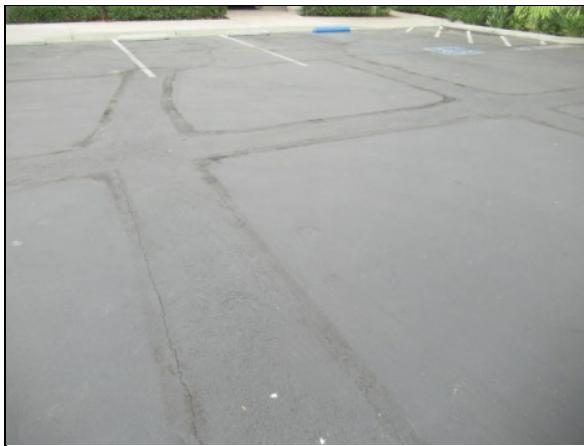
Comments: It is recommended the association consult with a qualified asphalt resurfacing contractor to evaluate the overall conditions and make recommendations for sectional repair or resurfacing projects. Some properties opt to hire a consultant to draft a scope of work and oversee the process of obtaining estimates, and overseeing the project for compliance to the specifications of the contract. This is a petroleum based product subject to significant cost fluctuations. The haul away is included in cost estimates. Keep surface well sealed on a 4 year routine cycle to protect base from premature deterioration. Perform remedial repair projects recommended by a licensed asphalt contractor with each seal cycle. The client should provide the reserve analyst with all the asphalt contractors and consultants recommendations and cost information.

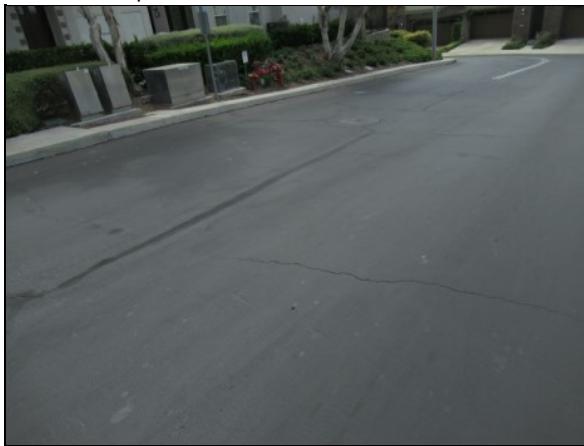
Comments: It is recommended the association consult with a qualified asphalt resurfacing contractor to evaluate the overall conditions and make recommendations for sectional repair or resurfacing projects. Keep surface well sealed on a 4 year routine cycle to protect base from premature deterioration. Perform remedial repair projects recommended by a licensed asphalt contractor with each seal cycle. It is beyond the scope of the reserve study to determine an actual cost for repair work. This is a petroleum based product subject to significant cost fluctuations. The estimated cost would include normal re-striping. The client should provide the reserve analyst with the asphalt contractors and consultants recommendations and cost information.

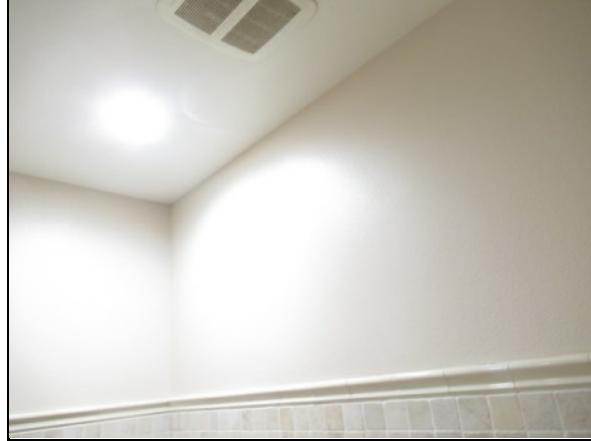
Comments: The cost is for good quality preparation and paint products. Painting the interior is typically performed with the exterior stucco painting project. Monitor for scuffing, paint surface deterioration, discoloration and fading. Maintain a routine paint cycle to provide a quality appearance. Touch up may be required between paint cycles over full surface painting. Plan for painting at the time frame below. Follow the recommendations of a qualified contractor for types of paint products and maintenance of the surfaces after painting is performed.

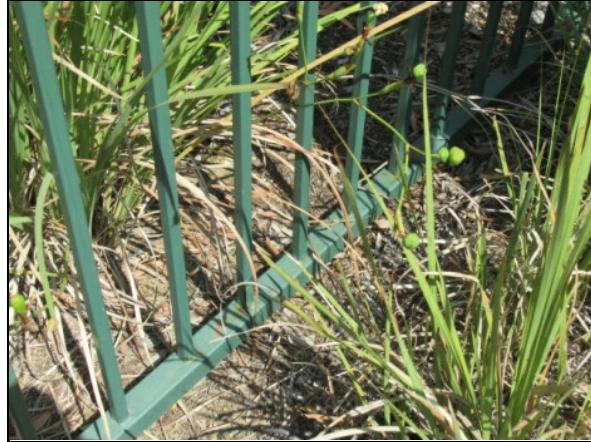
Comments: This is to cover two sides of fencing & railings as well as all other metal surfaces, primed and painted with good quality preparation and paint products. Expect to perform minor remedial repair with each paint cycle. Keep on routine paint cycle to avoid unnecessary repair projects and to protect metal from moisture causing corrosion and rust. Cost can increase if there is not reasonable access to all areas or if landscape is not removed from surfaces prior to painting. Cost is also increased if there is major prep work required prior to painting. This is typically caused by deferred painting projects.

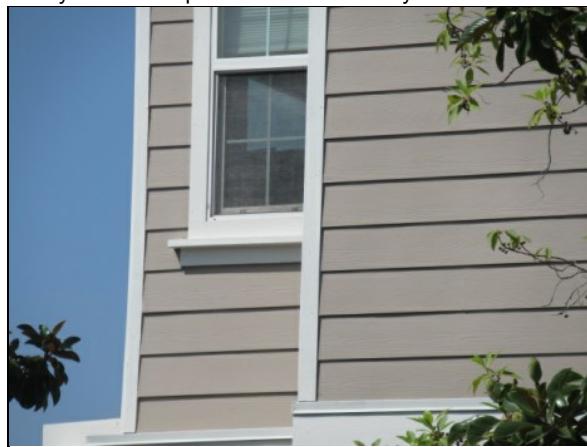
Comments: Expect to perform major wood repair project prior to wood surface painting projects. Keep wood well painted to avoid premature wood deterioration. Consult with a qualified contractor for actual evaluation of repair needs. This is an allowance to do some of the major repair work. It is beyond the scope of the reserve study to determine actual repair expenses.

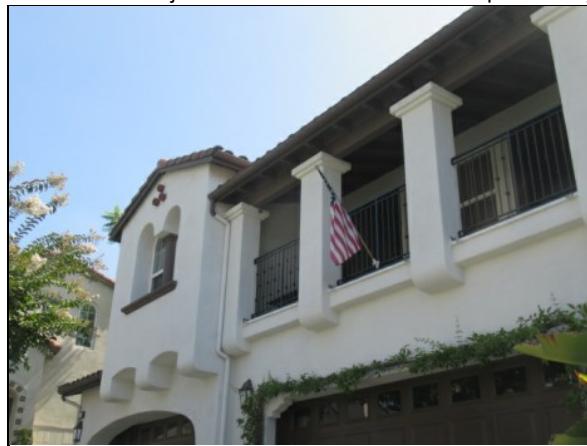
Comments: It is beyond the scope of the reserve study to determine the extent of any repair needs. Information contained in this component should come from the Elevated Structure Evaluation as required by Civil Code Section 5551. Consult with your qualified contractor for repair details. The information contained in this component is provided by the client. Good quality resurface and routine seal of any waterproof compound will prevent water penetration into the structure. Water intrusion may cause major extensive remedial repairs and accelerate deterioration. Some decks are not built with a waterproof surfaces. Follow manufacturer's recommendations of any materials applied to the decks. Funding is an allowance to perform repairs with each Elevated Structure evaluation. Cost should be adjusted as more information of repair history is available.

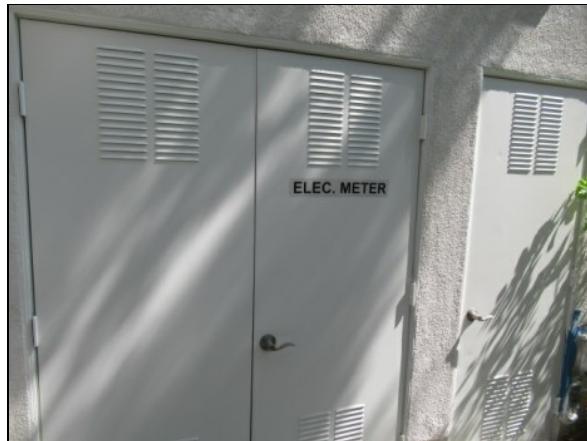
Comments: Some of the utility doors have minor rust. There is no expectation to replace all of the doors at one time and not all doors are inspected during the site visit. This is an allowance to replace the individual doors when necessary to properly maintain appearance and functionality. Typical major replacement occurs with paint cycles. Routine maintenance of closures, hinges, latches and hardware and other minor repairs should be handled using Operating funds. Keep all surfaces (other than glass) well painted and protected from moisture causing premature deterioration. As the history for replacement becomes evident, this should be adjusted to accurately meet the needs of the client.

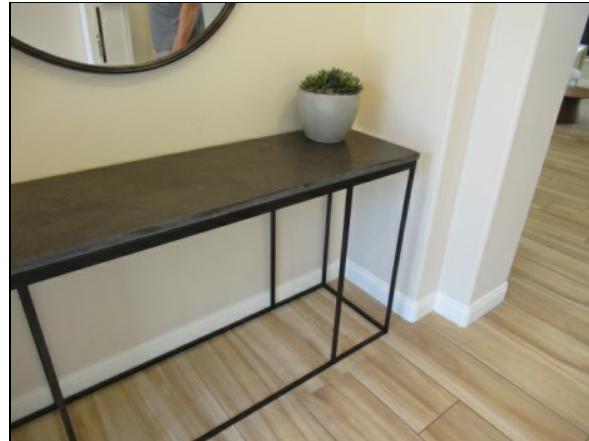
Comments: The replacement cycle will depend greatly on use and abuse. Provide routine cleaning and maintenance to reach or extend average life. There is no anticipation to replace "like for like". This is an allowance for replacement to update the facilities and provide functionality as needed for the community.
