SAN LORENZO HOMEOWNERS ASSOCIATION

COMMUNITY NEWSLETTER MARCH 2025

CONSTRUCTION DEFECT REPAIRS WELL UNDERWAY AND ACCELERATING

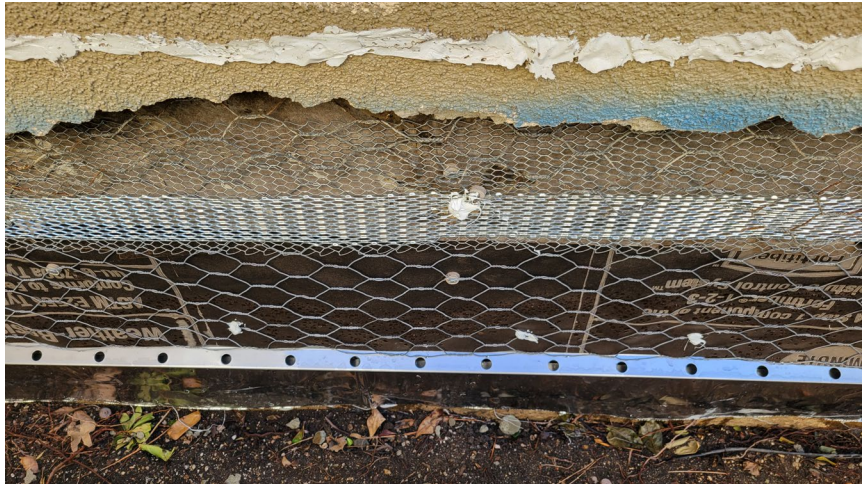
First Steps in the building repair process start with "LATH"

Work crews prepare the walls by removing protective plastic that has covered the walls for approximately 16 to 17 months during the City's stop work order. Crews prepare the walls, open up any additional areas required by the building inspector, install backing and support material for the "lath" installation phase where weatherproofing, caulking,

wire mesh, stainless steel weep screed and flashing are installed and readied for inspection by the building inspector.

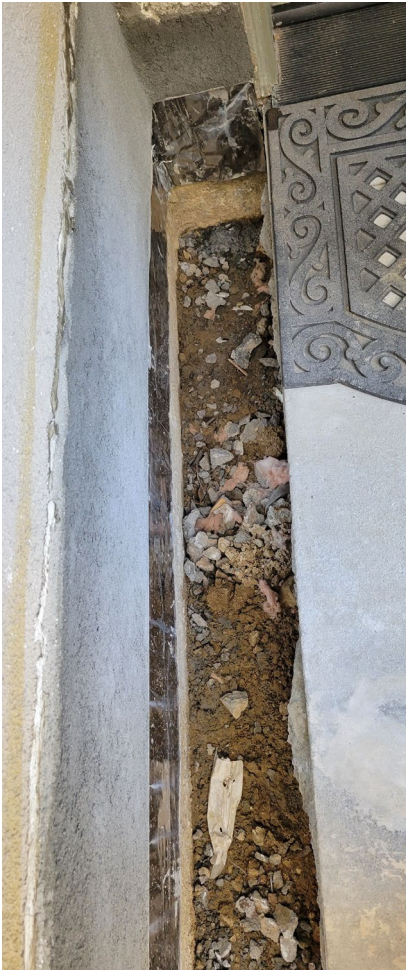
Scratch Coat is an intermediate step required by Yorba Linda

Although the structural engineer and repair contractor proposed a one step stucco application process, the City Building Department rejected the approach used in many construction projects in southern California and required the team to do a 3-step stucco application with inspections required and inspector approval prior to moving forward to the next step. A stucco "scratch

coat” is the second step in the three-coat stucco system, where a base coat material (cement, lime, sand and water) is applied to the wall and then scratched with horizontal lines to aid in the adhesion of the next coat.

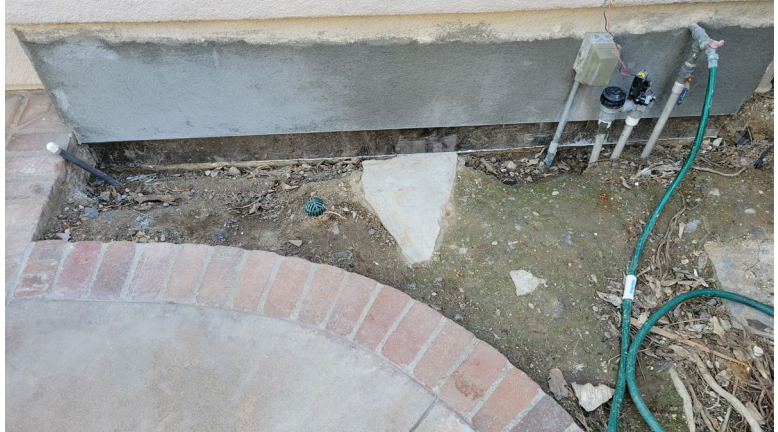
Brown Coat prepares the Stucco wall for final Color Coat layer

Once the scratch coat is signed off by the city building inspector, the team is permitted to apply the “brown coat” which is the next to the last step in the wall repair process. At this point, the wall appears almost ready to paint.

After the brown coat is approved by the City, the final color coat is applied

and the wall is ready to be painted by the HOA painting contractor to match the paint previously applied to the building stucco and concrete board siding.
