**San Lorenzo Community Assoc.
Yorba Linda, CA**

Report #: 1613-0
Beginning: January 1, 2025
Expires: December 31, 2025

**RESERVE STUDY
Update "With-Site-Visit"**

October 11, 2024

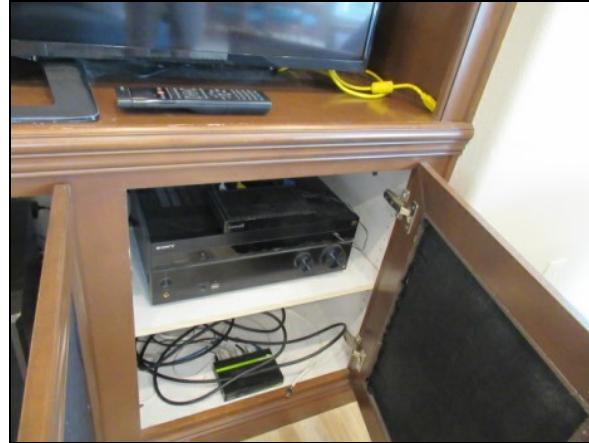
Comments: Keep equipment maintained by a qualified contractor to reach or extend average life. Minor replacement or repairs are best handled using Operating funds. A detailed list of components is maintained by the client and it is beyond the scope of this study to ascertain the actual replacement cost of all components. It is not anticipated the replacement will be "like for like" due to industry changes and needs of the community. This is an allowance for future replacement which can be changed by the client for cost and replacement cycle. Advise the reserve analyst when equipment replacement cost or cycle changes are anticipated.

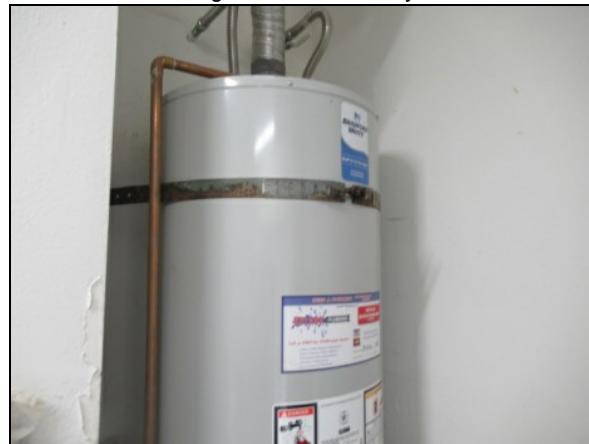
Comments: Regular inspections and maintenance is recommended. Flush tanks and inspect pressure relief valve each year. Funding includes removal and disposal of the old tank and replacement with a similar size and quality by a qualified plumbing contractor. Plan for replacement when the unit no longer functions reliably.

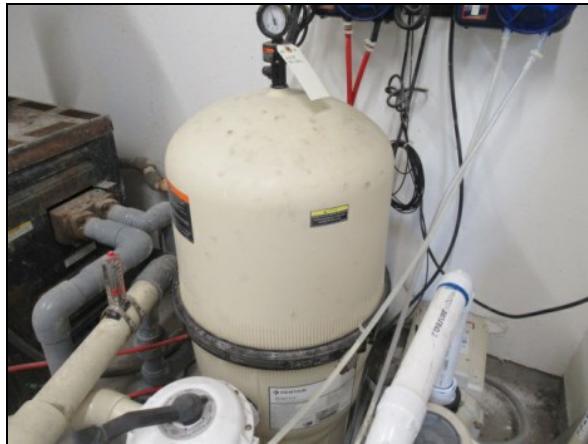
Comments: Pool vendor should inspect regularly for optimal performance and address any repairs or preventive maintenance as needed. Minimal or no subjective/aesthetic value for pool and spa equipment and useful life is based primarily on normal expectations for service/performance life in this location. Life expectancy can vary depending on location, as well as level of use and preventive maintenance. Unless otherwise noted, remaining useful life expectancy is based primarily on original installation or last replacement/purchase date, our experience with similar systems/components, and assuming normal amount of usage and good preventive maintenance. Cost estimates shown below assume replacement with similar filter types/sizes as existing.

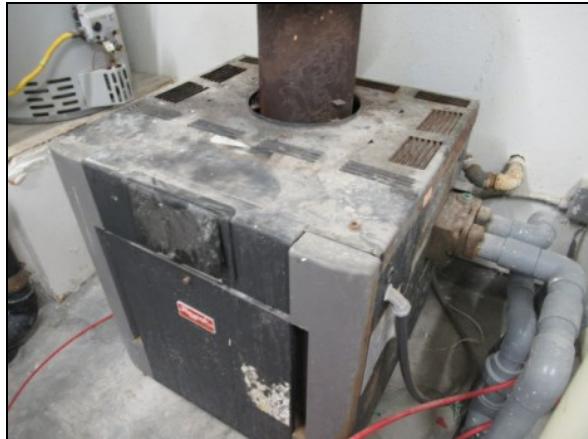
Comp #: 5815 Pool Heater - Replace**Quantity: (1) Raypak**

Comments: Expect to follow the recommendation of the pool maintenance vendor. Pool vendor should inspect heater regularly to ensure proper function, identify any required repairs, etc. Minimal or no subjective/aesthetic value for pool and spa equipment. Internal components were not analyzed during our site inspection. Useful life is based primarily on normal expectations for service/performance life in this location. Many Clients choose not to heat their pools year-round, which can prolong the life of the heater while reducing energy costs. Unless otherwise noted, remaining useful life expectancy is based primarily on original installation or last replacement/purchase date, our experience with similar systems/components, and assuming normal amount of usage and good preventive maintenance. When replacement models are being evaluated, we recommend considering high efficiency models which may have a higher initial cost but will ultimately be less expensive due to reduced energy usage.

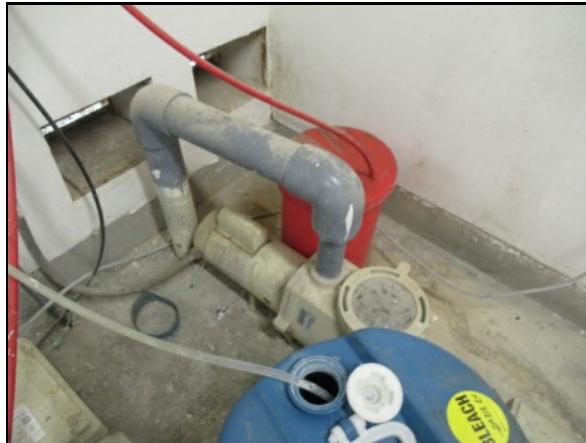
Comp #: 5817 Pool Pump - Replace**Quantity: (1) 3 hp Pentair**

Comments: Repair or replace motors using Operating Funds. Expect to follow the recommendation of the pool maintenance vendor. Pumps should be inspected regularly for leaks and other mechanical problems. Minimal or no subjective/aesthetic value for pool and spa equipment. Useful life is based primarily on normal expectations for service/performance life in this location. Unless otherwise noted, remaining useful life expectancy is based primarily on original installation or last replacement/purchase date, our experience with similar systems/components, and assuming normal amount of usage and good preventive maintenance. Cost shown is based on replacement with the same types/sizes, and may include a small allowance for new piping, valve replacements, and other repairs to be conducted as needed.

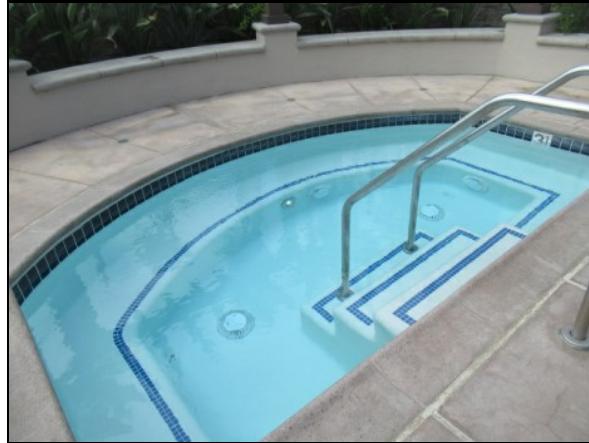
Comments: Minor repairs and routine cleaning/maintenance should be considered an Operating expense. Pool resurfacing will restore the aesthetic quality of the spa while protecting the actual concrete shell of the spa from deterioration. This type of project is best suited for slow/offseason to minimize downtime during periods when spa is used heavily. Should be expected at the approximate interval shown below; in some cases, schedule may need to be accelerated due to improper chemical balances or aesthetic preferences of the Client. While drained for resurfacing, any other repairs to lighting, handrails, stairs, ladders, etc. should be conducted as needed and funding is included for these components. This cost does not include any re-plumbing of water or drain lines or related work.

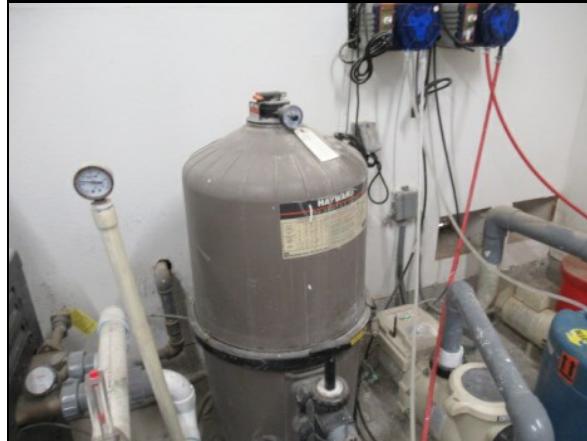
Comp #: 5822 Spa Filter - Replace

Comments: Expect to follow the recommendation of the pool maintenance vendor. Pool vendor should inspect regularly for optimal performance and address any repairs or preventive maintenance as needed. Minimal or no subjective/aesthetic value for pool and spa equipment and useful life is based primarily on normal expectations for service/performance life in this location. Life expectancy can vary depending on location, as well as level of use and preventive maintenance. Unless otherwise noted, remaining useful life expectancy is based primarily on original installation or last replacement/purchase date, our experience with similar systems/components, and assuming normal amount of usage and good preventive maintenance. Cost estimates shown below assume replacement with similar filter types/sizes as existing.

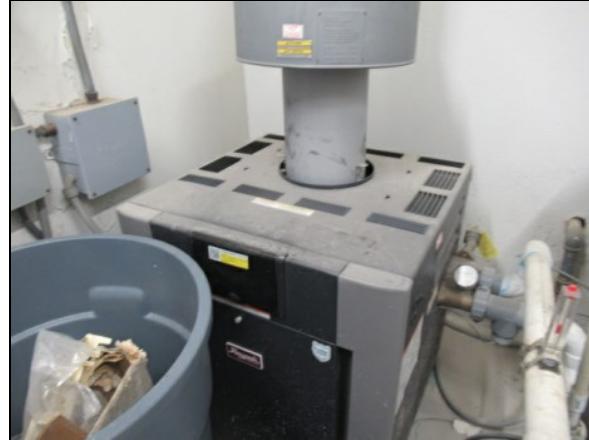
Comp #: 5825 Spa Heater - Replace**Quantity: (1) Raypak 407**

Comments: Expect to follow the recommendation of the pool maintenance vendor. Pool vendor should inspect heater regularly to ensure proper function, identify any required repairs, etc. Minimal or no subjective/aesthetic value for pool and spa equipment.

Internal components were not analyzed during our site inspection. Many Clients choose not to heat their pools year-round, which can prolong the life of the heater while reducing energy costs. Unless otherwise noted, remaining useful life expectancy is based primarily on original installation or last replacement/purchase date, our experience with similar systems/components, and assuming normal amount of usage and good preventive maintenance. When replacement models are being evaluated, we recommend considering high efficiency models which may have a higher initial cost but will ultimately be less expensive due to reduced energy usage.

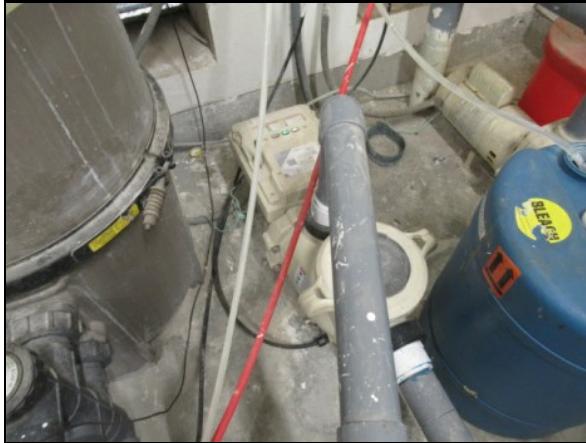
Comp #: 5827 Spa Pumps - Replace**Quantity: (2) 3hp VSP**

Comments: Repair or replace motors using Operating Funds. Expect to follow the recommendation of the pool maintenance vendor. Pumps should be inspected regularly for leaks and other mechanical problems. Minimal or no subjective/aesthetic value for pool and spa equipment. Useful life is based primarily on normal expectations for service/performance life in this location. Unless otherwise noted, remaining useful life expectancy is based primarily on original installation or last replacement/purchase date, our experience with similar systems/components, and assuming normal amount of usage and good preventive maintenance. Cost shown is based on replacement with the same types/sizes, and may include a small allowance for new piping, valve replacements, and other repairs to be conducted as needed.

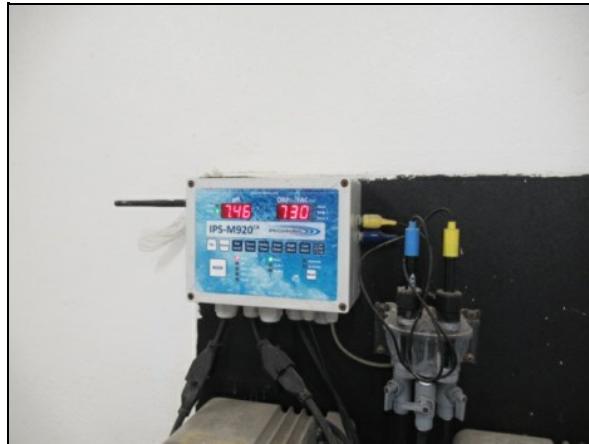
Comp #: 5848 Chemical Controllers - Replace**Quantity: (2) IPS-M920**

Comments: The California code of Regulations (Title 22) requires daily testing and written recording of pH, chlorine, and heated pool water temperature at public pools. For sites where there are less than 25 housing units, testing and recording is required twice a week, no more than four days apart. —Every automated chemical controller needs regular calibration in order to work properly. Follow all manufacturer's instructions. Install the automated chemical controller according to the manufacturer's instructions and follow all safety precautions. Keep the automated chemical controller manufacturer's instructions at the pool site for reference.

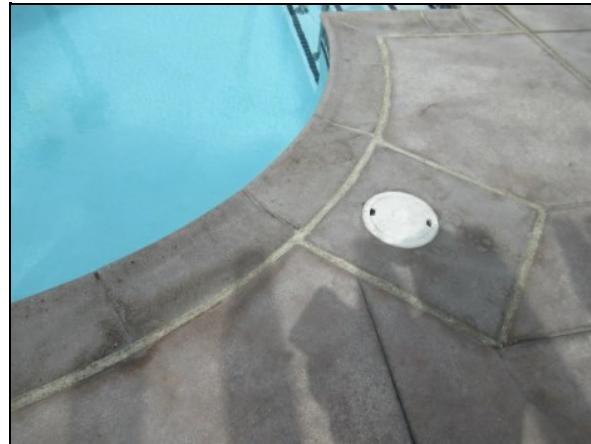
Comp #: 5860 Pool/Spa Skimmers - Replace**Quantity: (3) Skimmers**

Comments: The vendor reports the one at the deep end of the pool is cracked. These have a long and unpredictable useful life and are not a routine reserve component. It is best to rely on the expertise of the maintenance vendor or other reliable contractor for replacement consideration. The replacement is best done when the pool and/or spa is being resurfaced. It is beyond the scope of this study to ascertain the condition of the skimmer as it is below deck surface.

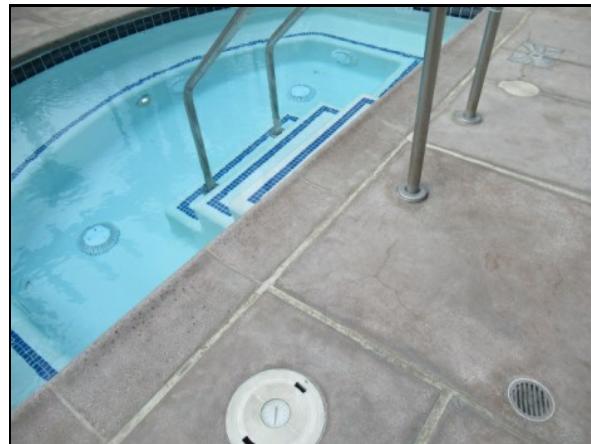
Comp #: 5870 Pool & Spa Lights - Replace**Quantity: (3) Fixtures**

Comments: These were not tested during daylight hours. Follow the recommendations of the maintenance vendor. We recommend replacement with LED fixtures when appropriate. Follow recommendations of the manufacturer for use and maintenance. The replacement is best done when the pool and/or spa is being resurfaced. It is beyond the scope of this study to ascertain the condition of the fixtures, typically unlit during daylight hours. They will be presumed functional unless notified otherwise.

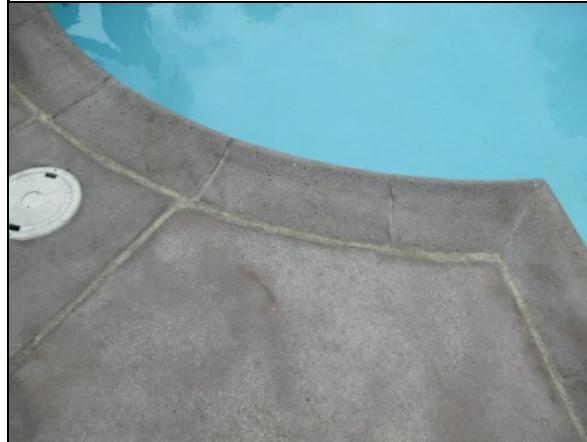
Comp #: 5950 Pool Area Mastic - Replace

Comments: Keep mastic in good condition to prevent water penetration under deck causing expansion cracking to deck and coping.

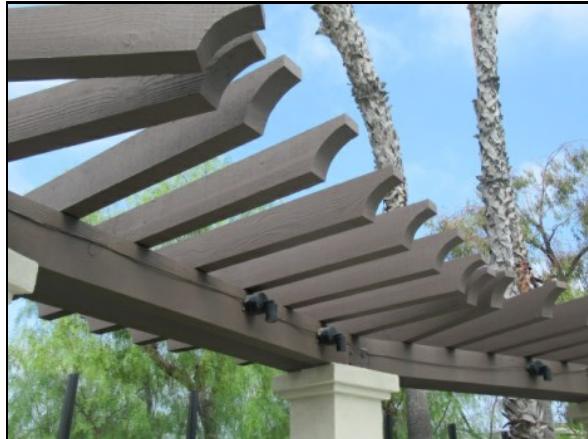
History: 2023, repaired \$41,209.

Comments: As routine maintenance, inspect regularly and repair individual pieces or sections as-needed from general Operating funds. Clean and paint/stain along with other larger projects or as general maintenance to preserve the appearance of the trellis and extend its useful life. If present, vegetation should be well-maintained and not allowed to become overgrown, which can eventually compromise the structure. Assuming ordinary care and maintenance, plan for major repairs or possibly complete replacement (if warranted) at roughly the interval indicated below.

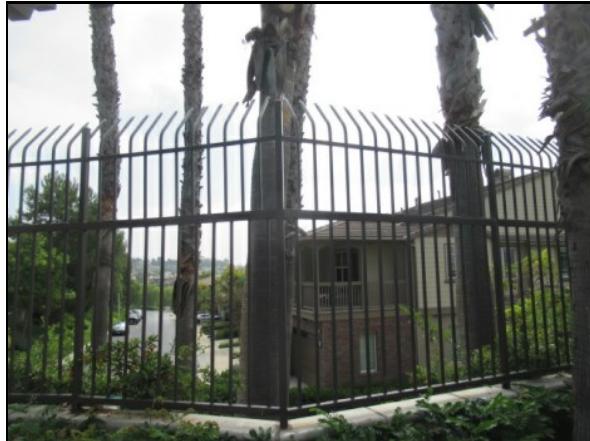
Comp #: 5520 (2029) Iron Fence - Repair/Replace

History: Bids for major work: 2022-23, 50% repaired to "like new", remainder scheduled 2028.

Comments: Not all of the fencing was accessed during inspection, consult with a qualified contractor to evaluate the structural integrity of the entire fencing and recommend repairing options or replacement. All metal will eventually break down due to a combination of sun and weather exposure. Sometimes this is exacerbated by other factors such as irrigation overspray, abuse and lack of preventive maintenance. For some types of fencing, complete replacement is advisable over minor repairs. Remaining useful life of the fencing may be prolonged by regular painting to protect the metal from rust and corrosion. Cost estimate range below assumes full replacement with similar material, style and quantity as existing. Remaining life can often be extended with partial repair and/or replacement and quality painting application.

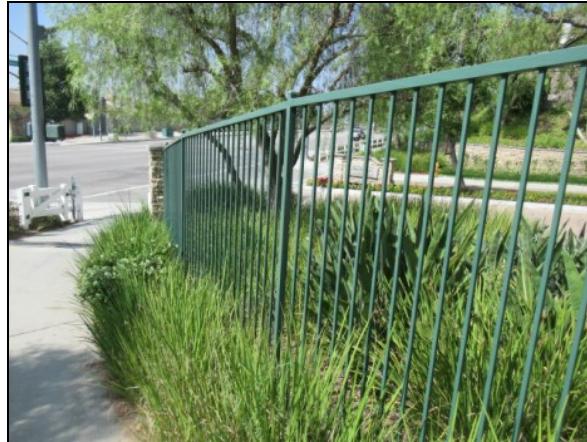
Comp #: 5520 (2044) Iron Fence - Repair/Replace**Quantity: 50% of Approx 22,560' GSF**

History: Bids for major work: 2022-23, 50% repaired to "like new", remainder scheduled 2028.

Comments: Not all of the fencing was accessed during inspection, consult with a qualified contractor to evaluate the structural integrity of the entire fencing and recommend repairing options or replacement. All metal will eventually break down due to a combination of sun and weather exposure. Sometimes this is exacerbated by other factors such as irrigation overspray, abuse and lack of preventive maintenance. For some types of fencing, complete replacement is advisable over minor repairs. Remaining useful life of the fencing may be prolonged by regular painting to protect the metal from rust and corrosion. Cost estimate range below assumes full replacement with similar material, style and quantity as existing. Remaining life can often be extended with partial repair and/or replacement and quality painting application.

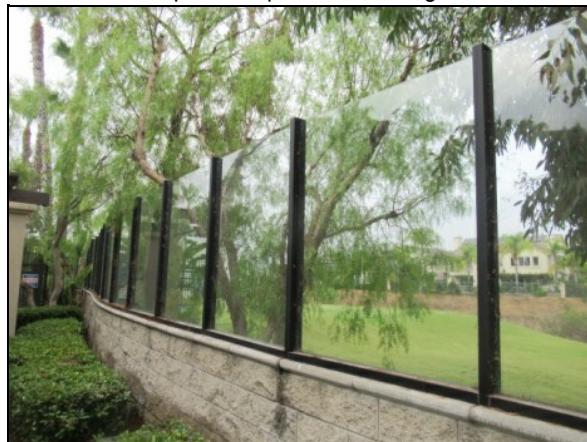
Comp #: 5545 View Fencing - Replace**Quantity: Approx 655' LF x 5' H**

Comments: Not all of the fencing was inspected during the site visit. Consult with a qualified contractor to evaluate the structural integrity of the entire fencing and recommend repairing options or replacement. Monitor for structural integrity, inspect and repair framework as necessary using Operating Funds. Plexiglas is an extensive life component if properly maintained and not damaged. Keep clean using Operating funds. Avoid irrigation overspray to eliminate calcium build-up.. Eventually the material will become "foggy" and deteriorated. To maintain aesthetics, plan to replace the fencing in the future.

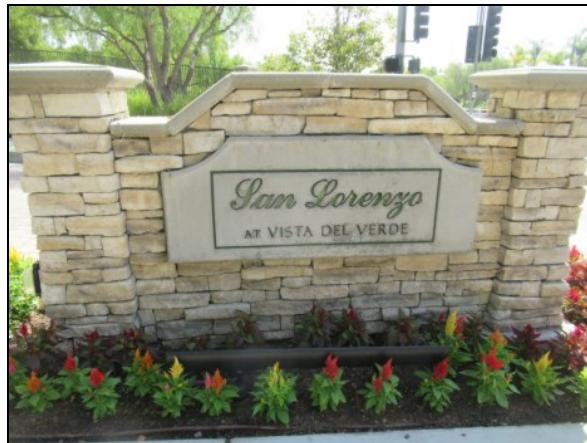
Comp #: 6810 Monument Letters - Replace/Refurb

Comments: The monument is legible but could use cleaning and touch-up paint. The letters are sandblasted into the concrete and then painted. Letters become faded over time. Expect to clean the concrete and repaint the letters to maintain a quality appearance.
